Subjects: Dock and Sea Trials "RTA 1" Catamaran Passenger Ferry
Metal Shark Franklin, LA.

The following was observed during my visit of April 27, 2018

First Catamaran Ferry "RTA 1"

Two (2) 32.0 (m) X 7.7 (m) X 1.35(m)RTA Passenger Ferries

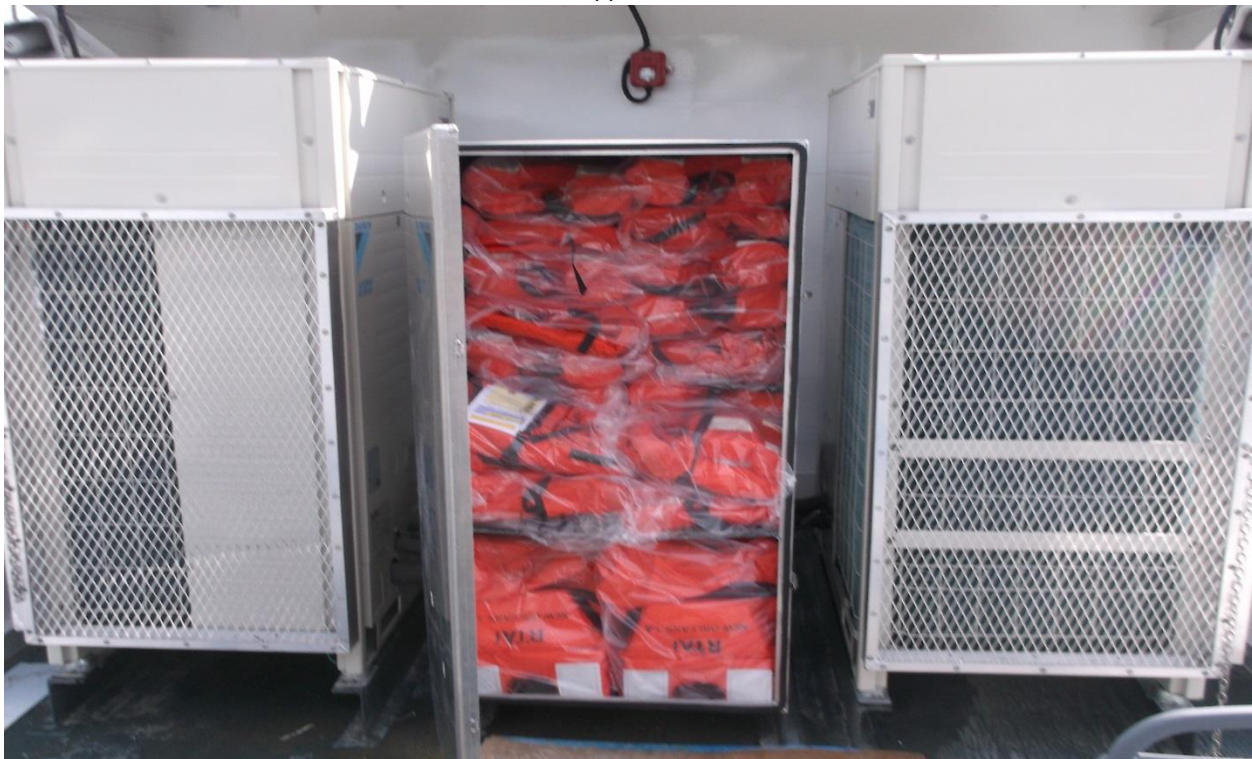
View of life preservers (PFDs) placed into the holding box of upper deck

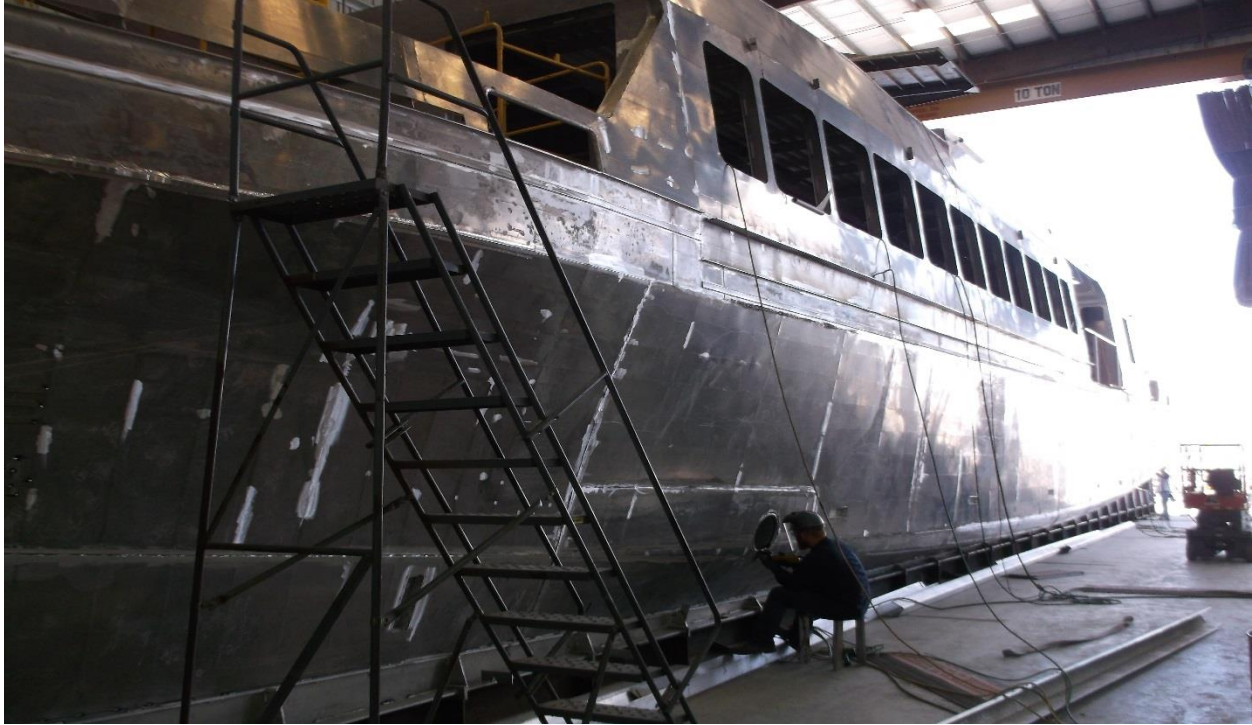
"RTA 2" forward portside view 5/31/18

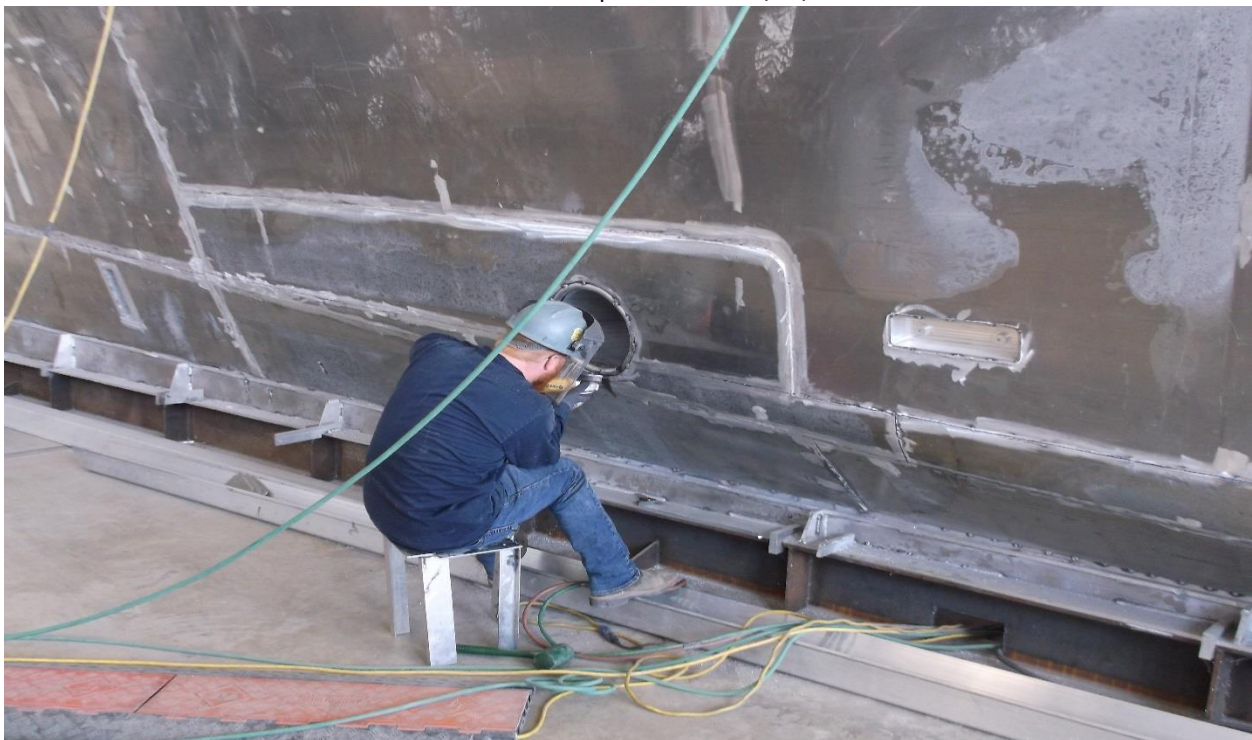
Closer view with worker installed outer tie-in bar onto the port bow thruster housing pipe to shell plating

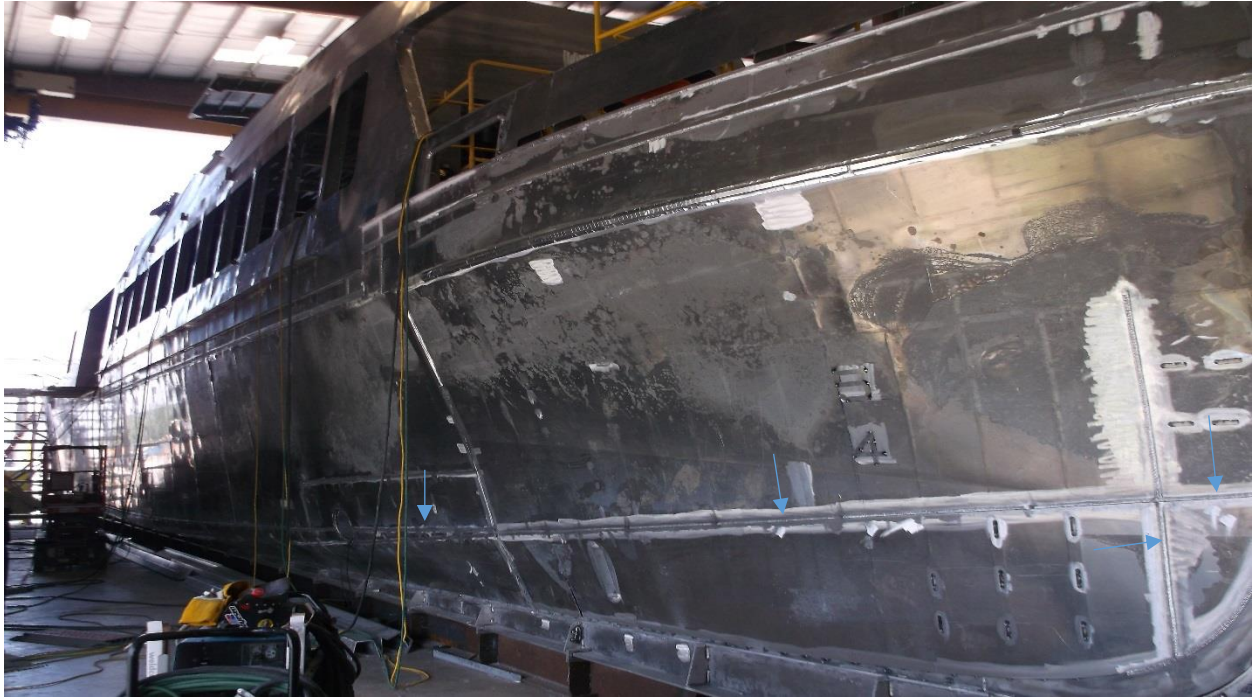
View of forward hull starboard side with lower shell plating seams welded

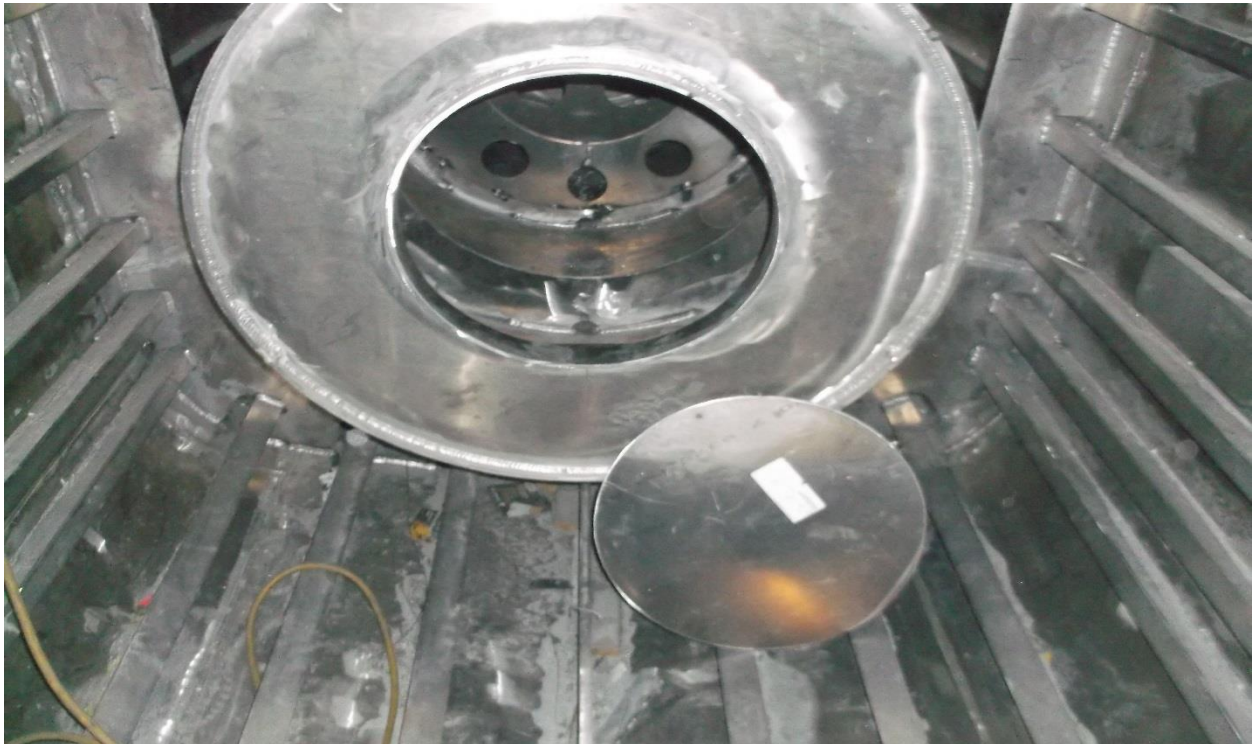
The fuel oil tanks having the previously installed large inspection/cleanout flanges removed from the ends with insert plates installing in accordance with USCG requirements. The single top side oval bolted flange/ access/cleanouts were observed installed into each tank ready for welding.

Typical view of fuel oil tanks having forward flanges removed as per USCG requirement with insert plate fabricated ready to install

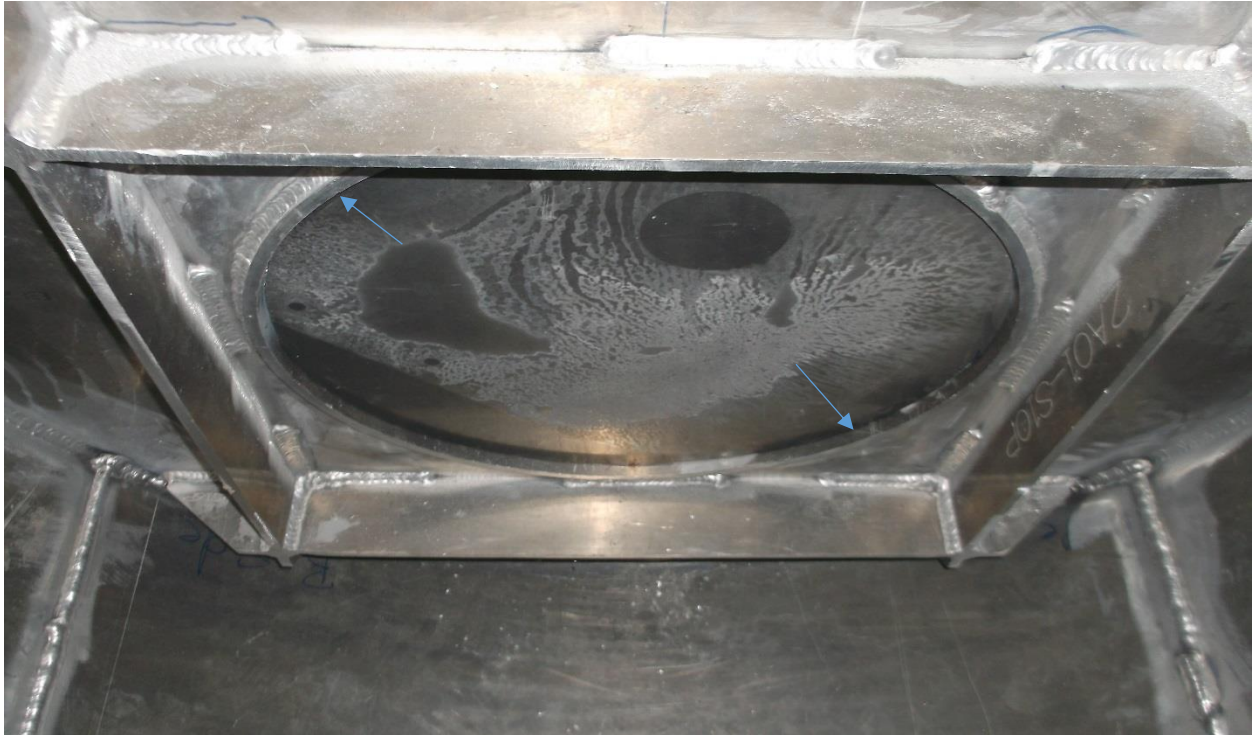
Typical internal view of fuel oil tanks with insert plate installed ready to weld

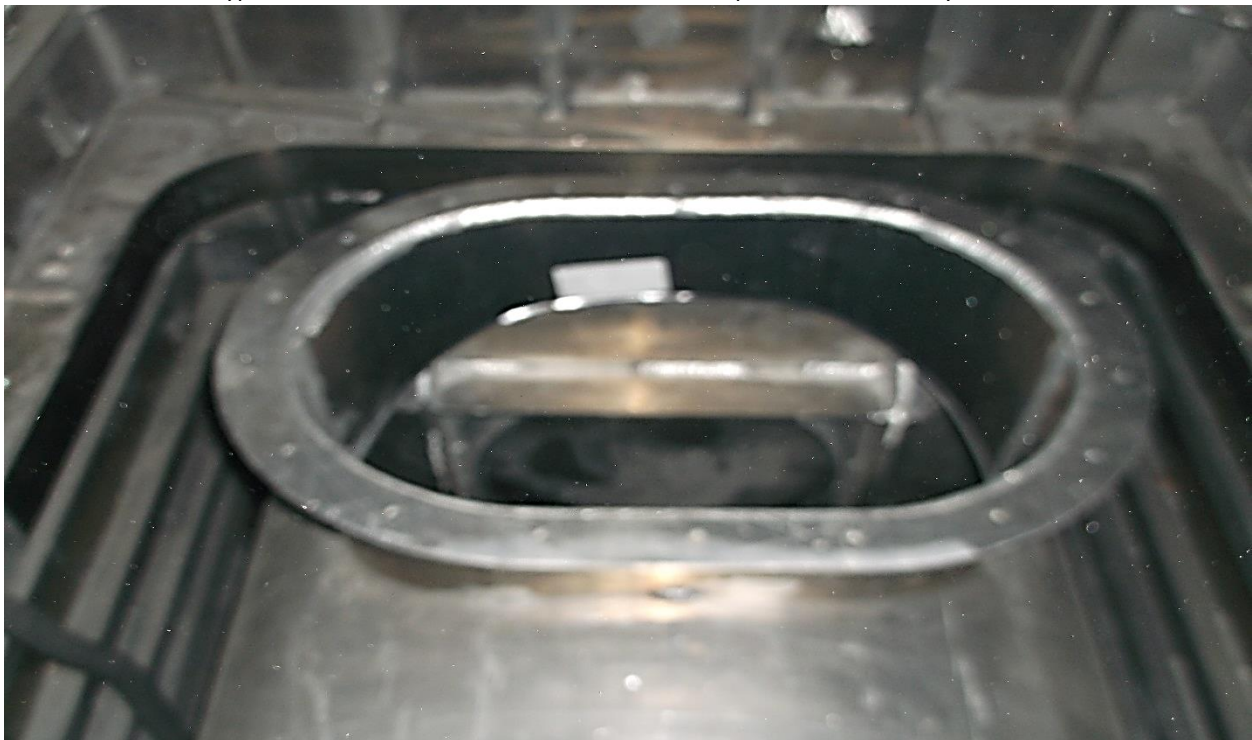
Typical view of new access/cleanout bolted flange installed onto fuel oil tanks

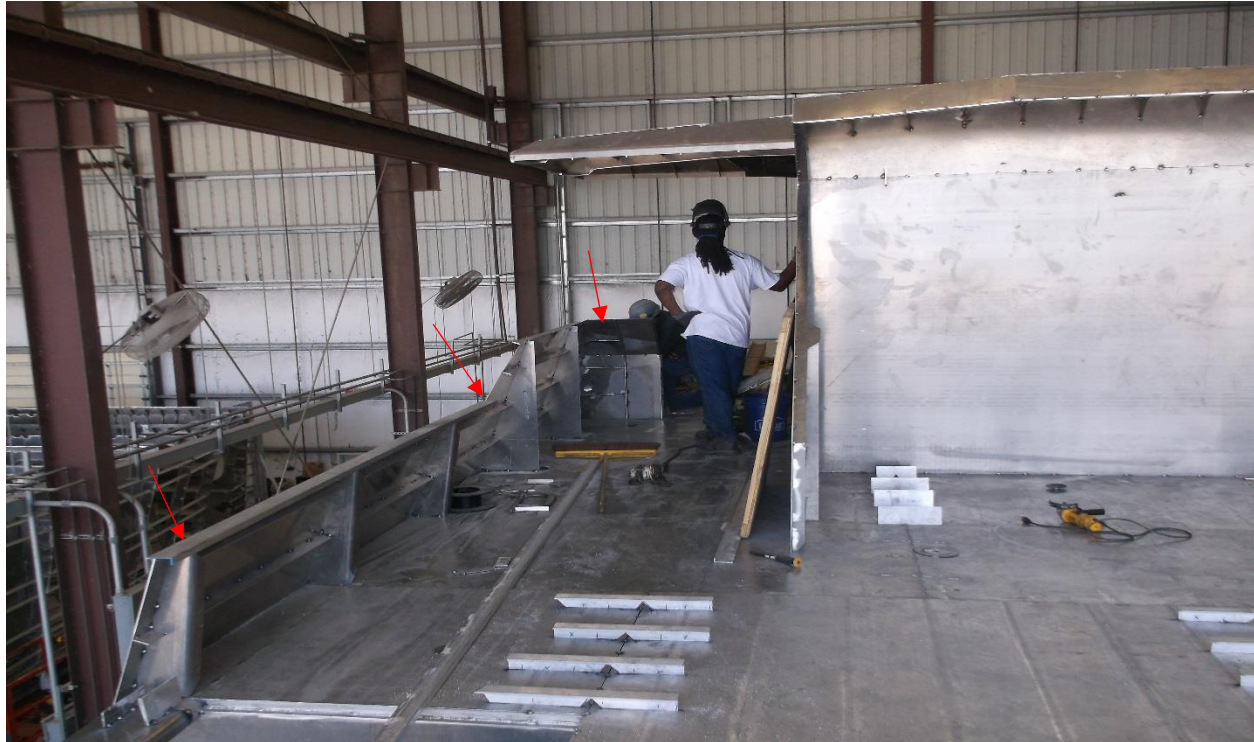
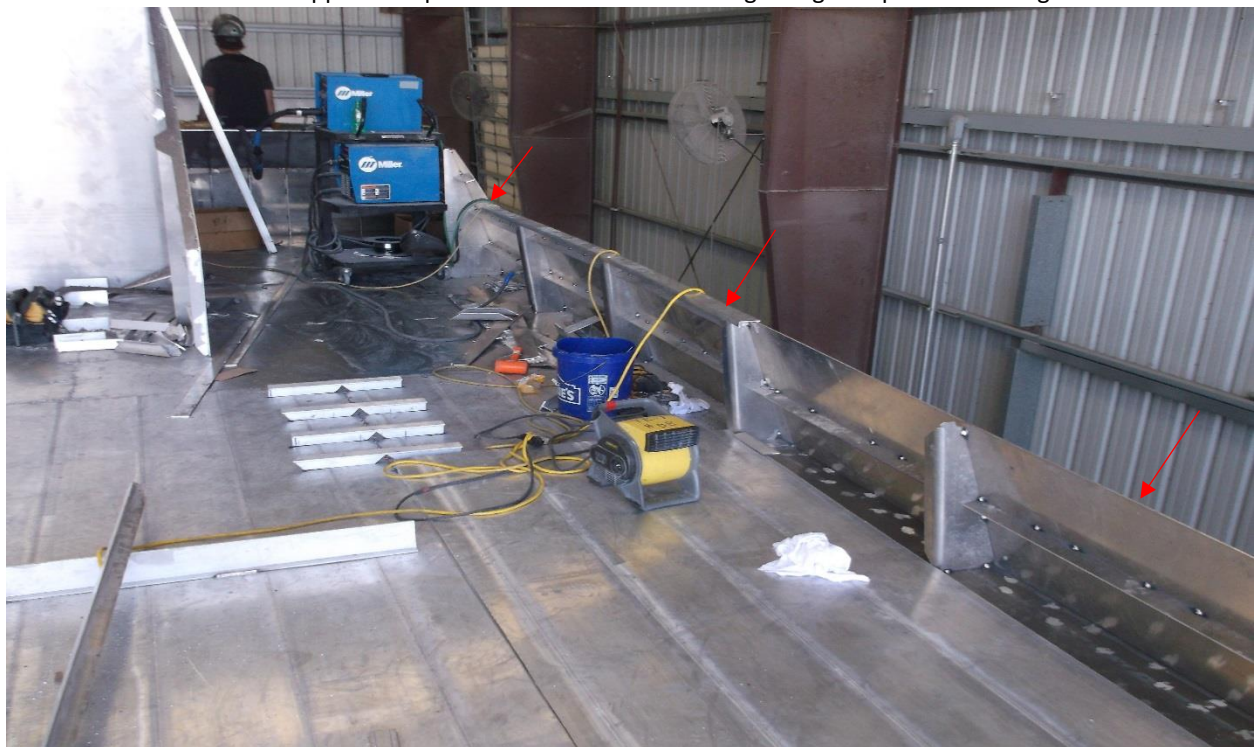
The upper deck having the forward and aft areas of deck plating installed with side guard plating approximately 80% installed around the perimeter. Workers were noted fitting the forward portside access gate next to pilothouse.

View of upper deck port and starboard side having side guard plates installing

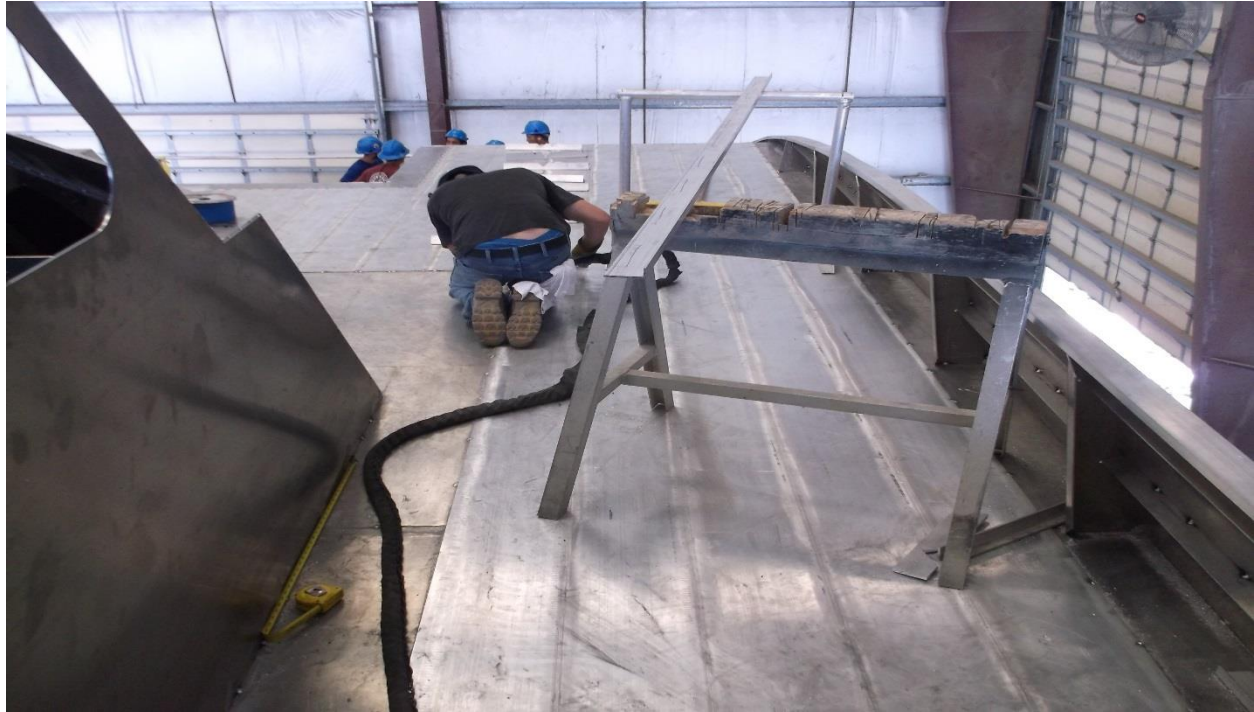
Another view of upper deck plating tack welding at seams

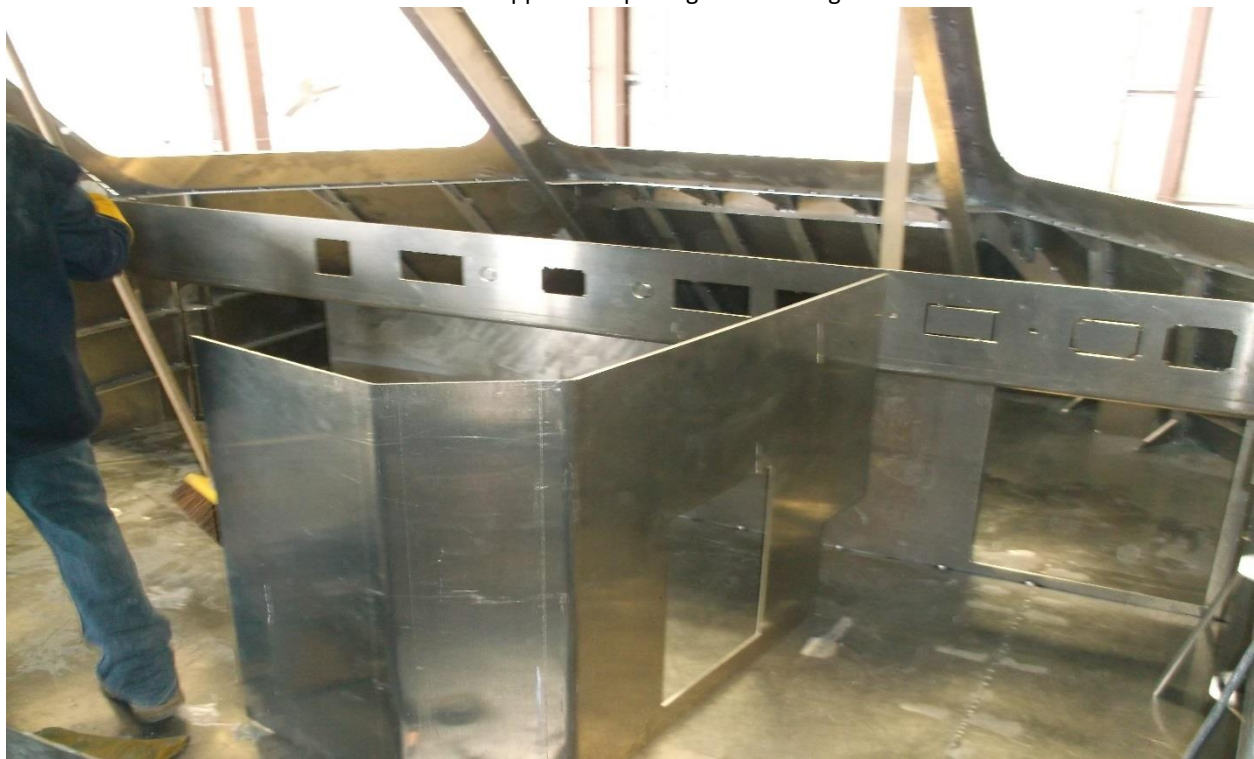
View of precut aluminum console face panel installed

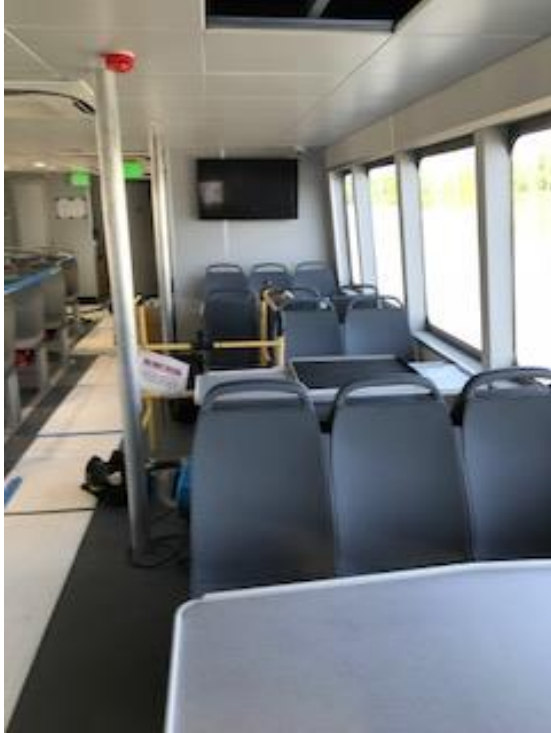
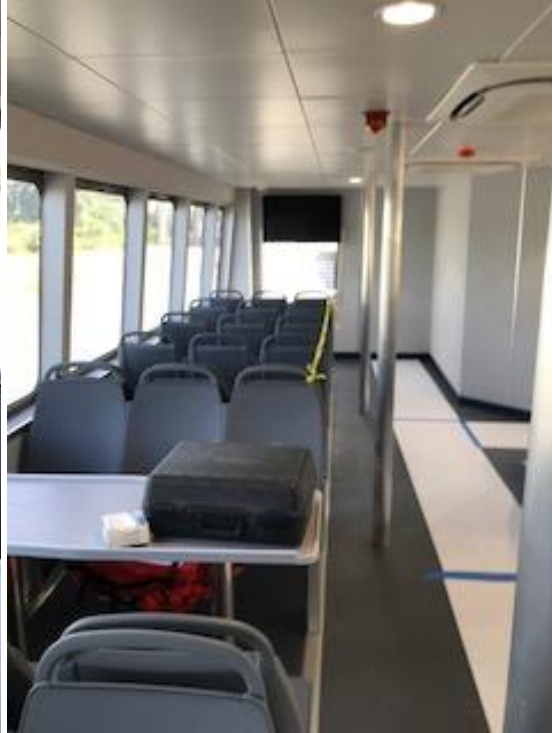
"RTA 1" Views inside main deckhouse portside with TV monitors installed 6/6/18

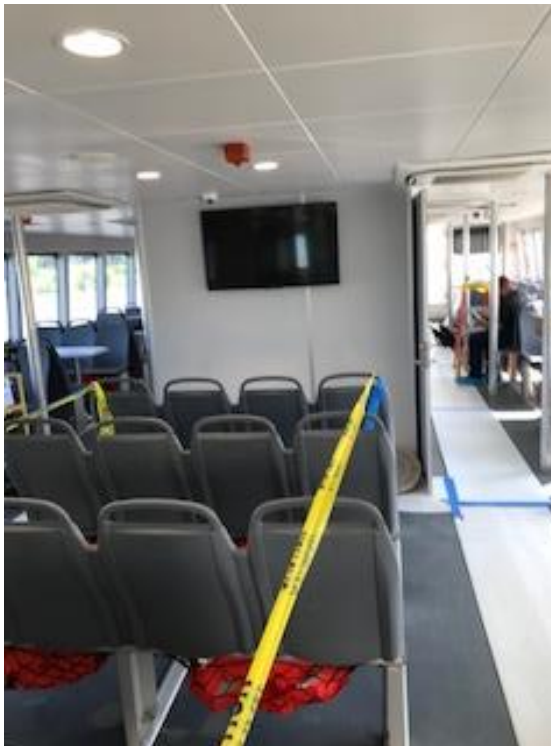
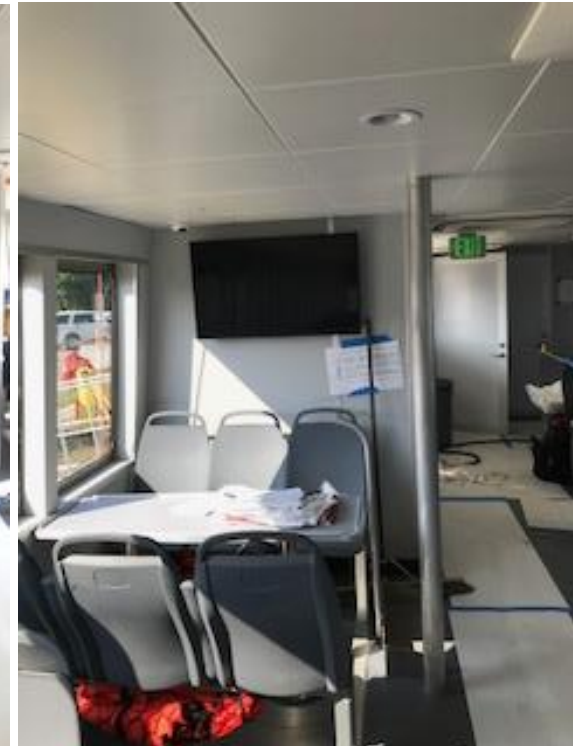
More view of TV monitors installed at mid-ship and aft starboard side

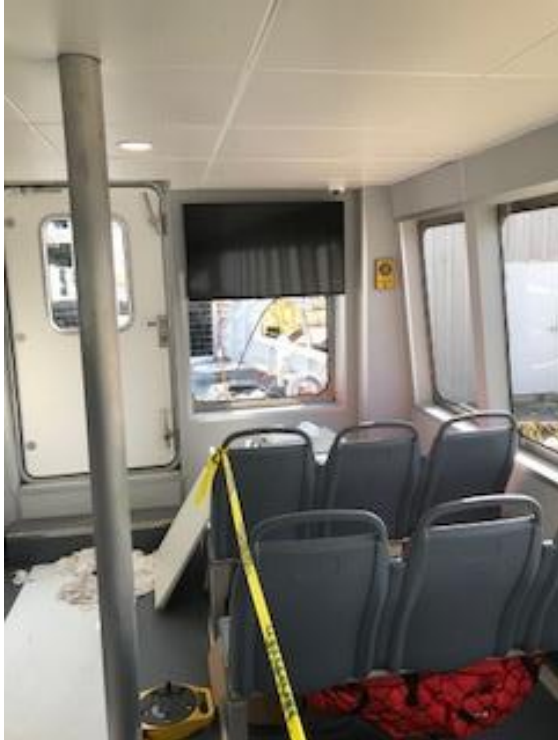
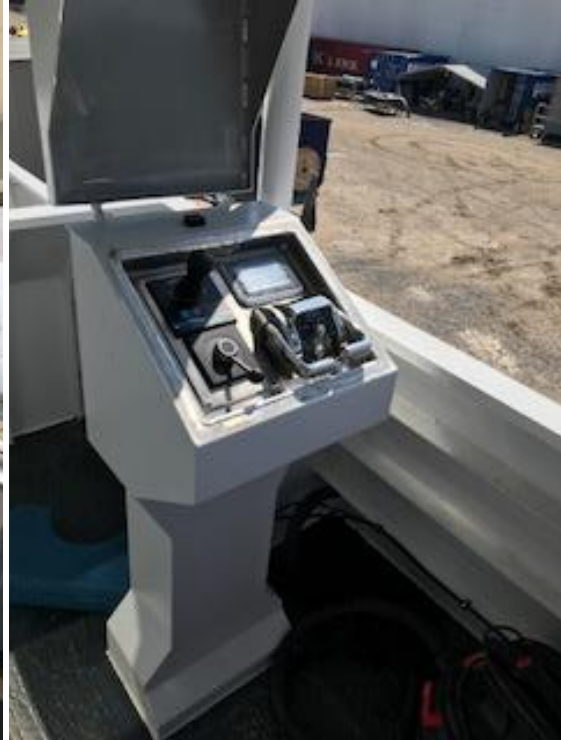
Monitor installed forward starboard inside deckhouse Starboard wing control station with controls installed

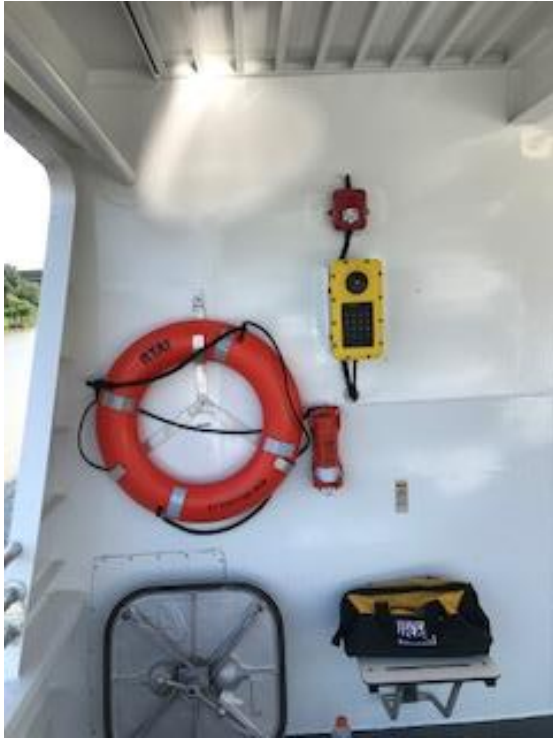
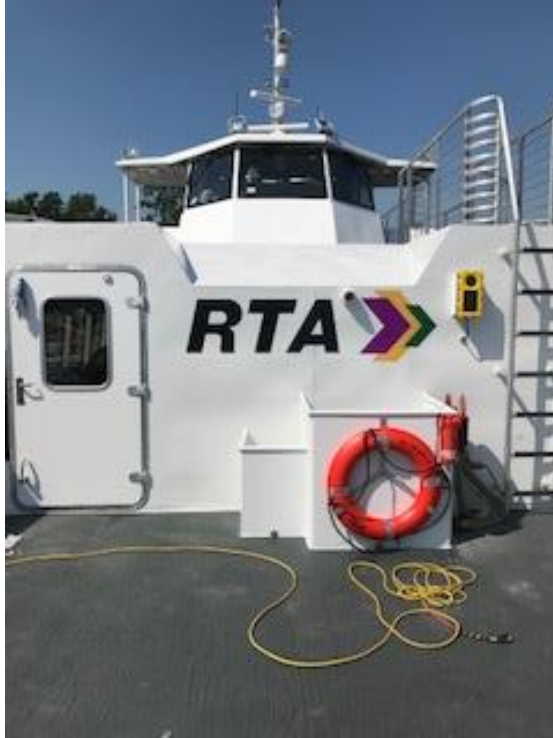
View of aft and forward life rings and hailing station 6/6/18

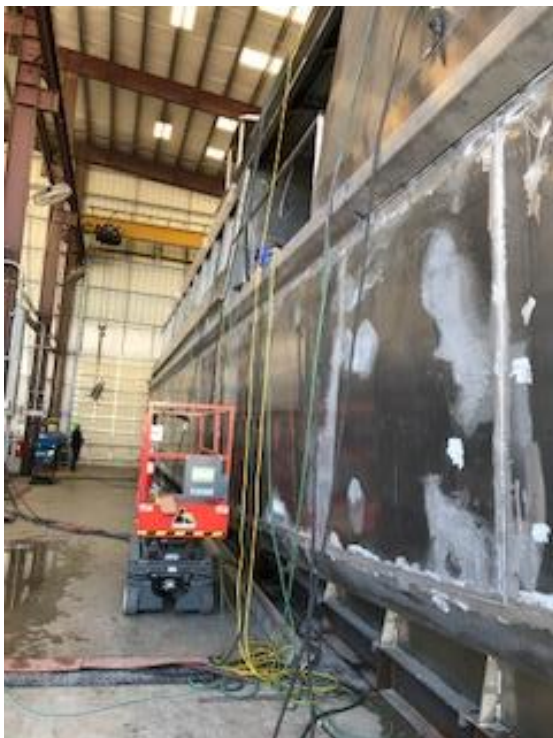
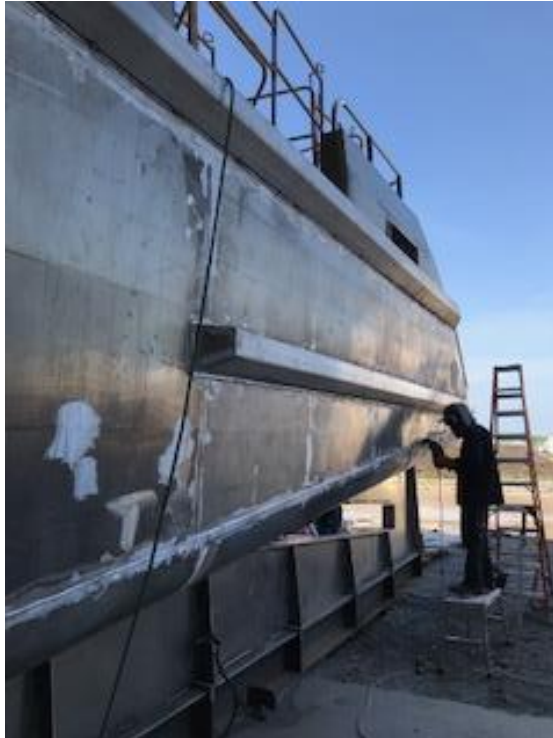
'RTA 2" portside with fenders installed and welder working aft lower longitudinal plating seam 6/6/18

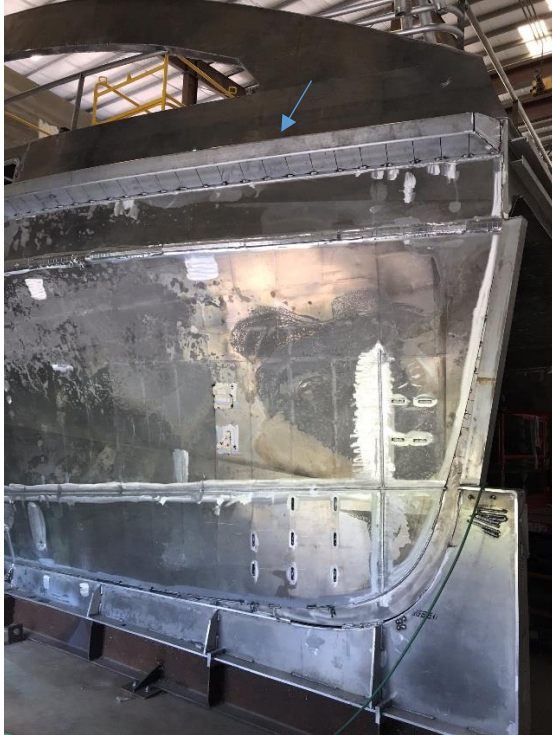
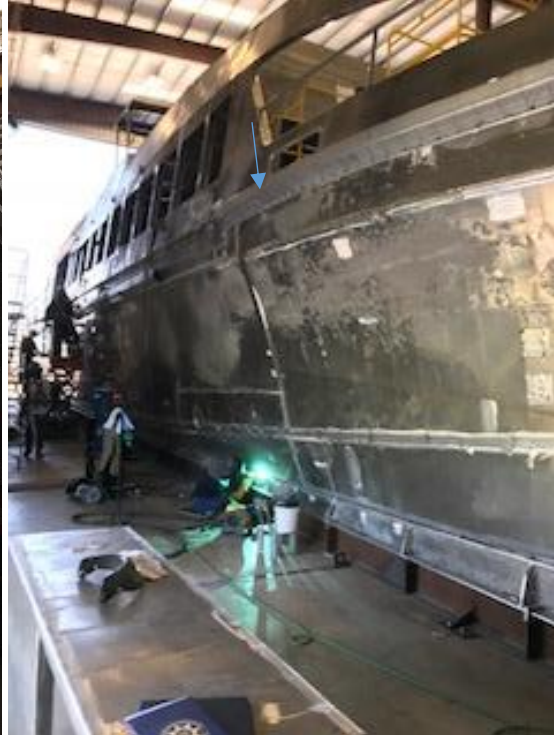
Starboard side fenders installing and welder working the longitudinal bilge shell plating seam

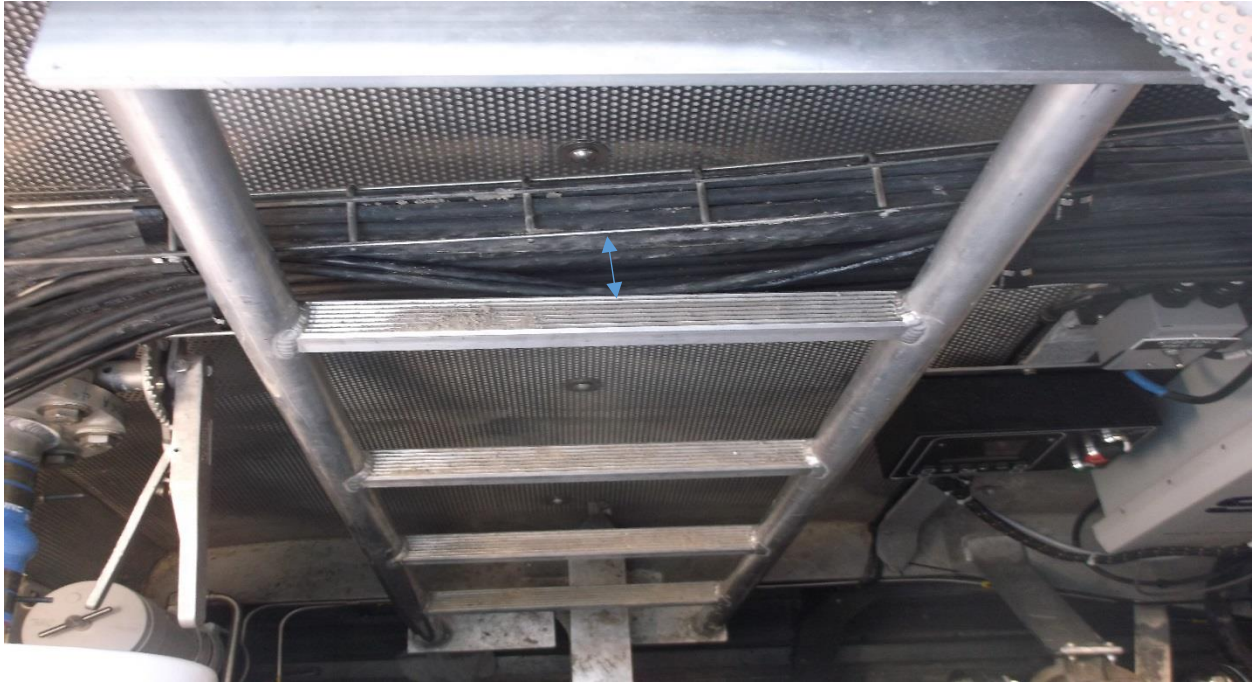
Typical view of machinery space forward and aft access ladders with first rung inline with electrical cable raceway not allowing for good footing (safety issue)

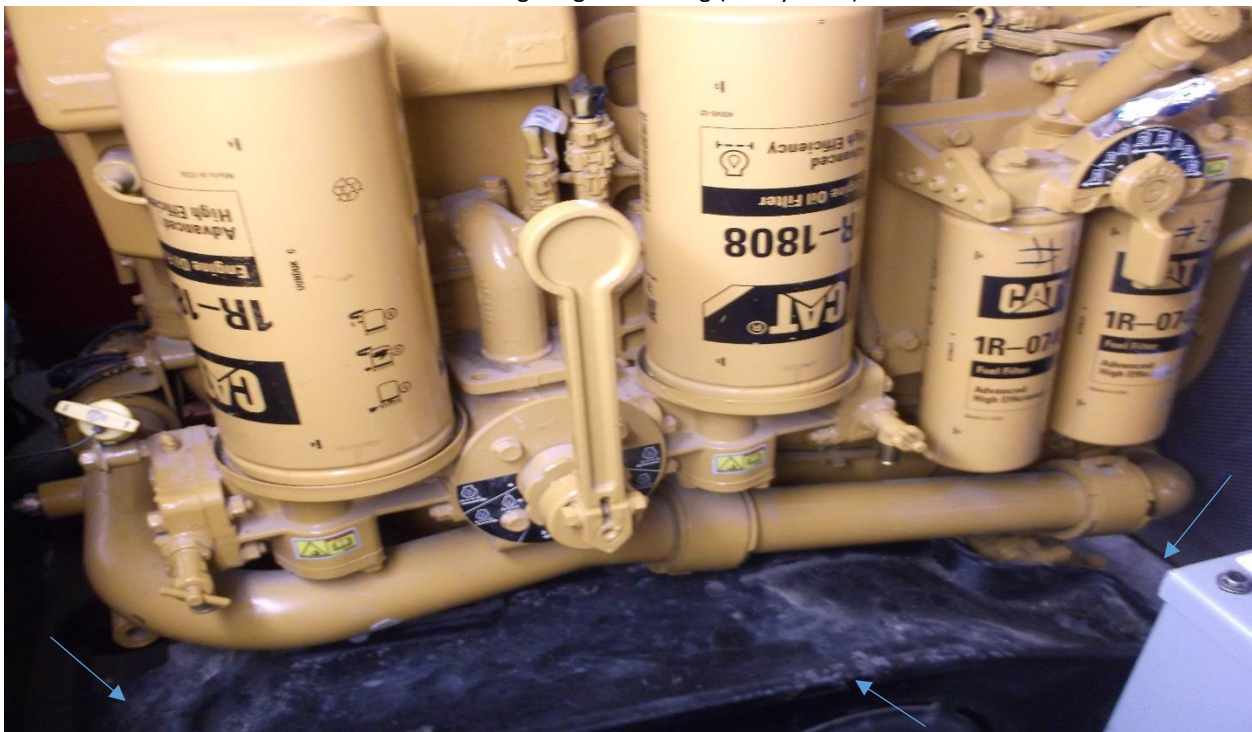
5. The fuel and lube oil filters of main engines having a small built-in formed plastic catch basin which doesn't appear large enough to hold fluids from filters and could possible leak into bilge area. The bilge is not ease to access if cleaning is needed (**possible safety and/or fire hazard**).

Typical view of main engine filters having a small catch basin at bottom which will not hold much fluids and would likely spilling into bilge area during filter changes (safety/fire issue)

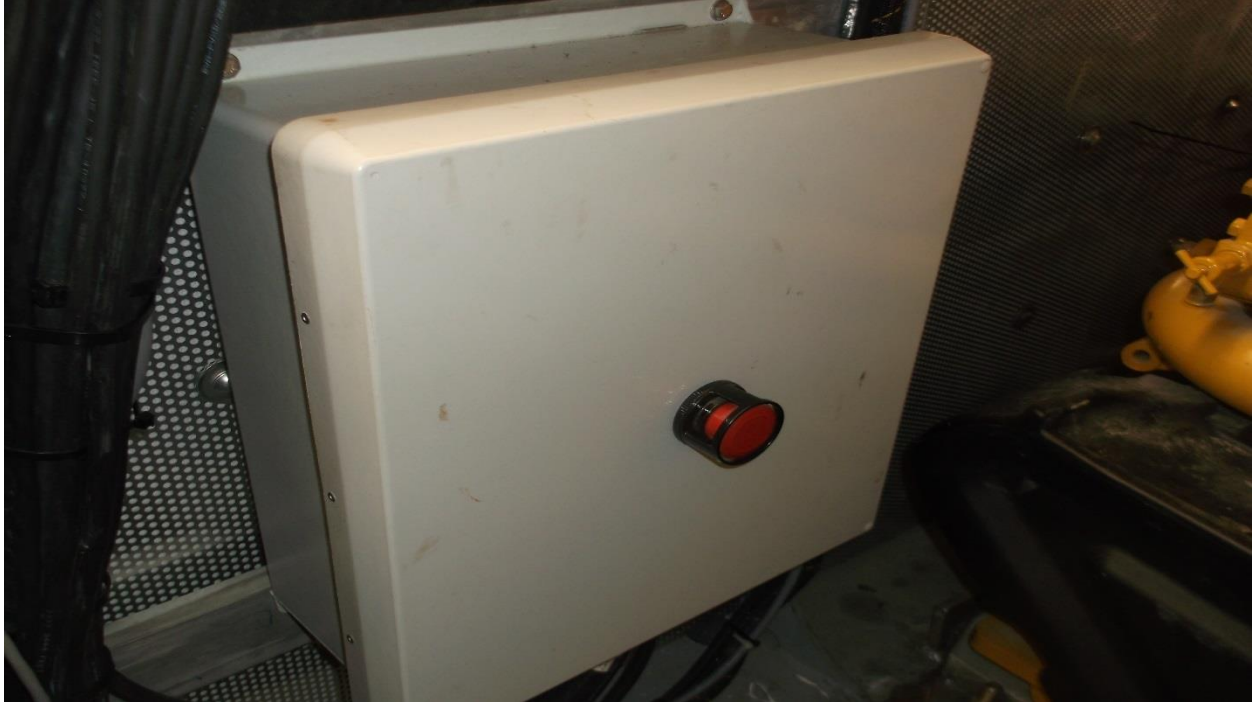
Unmarked panel appearing to be emergency shut down in machinery space

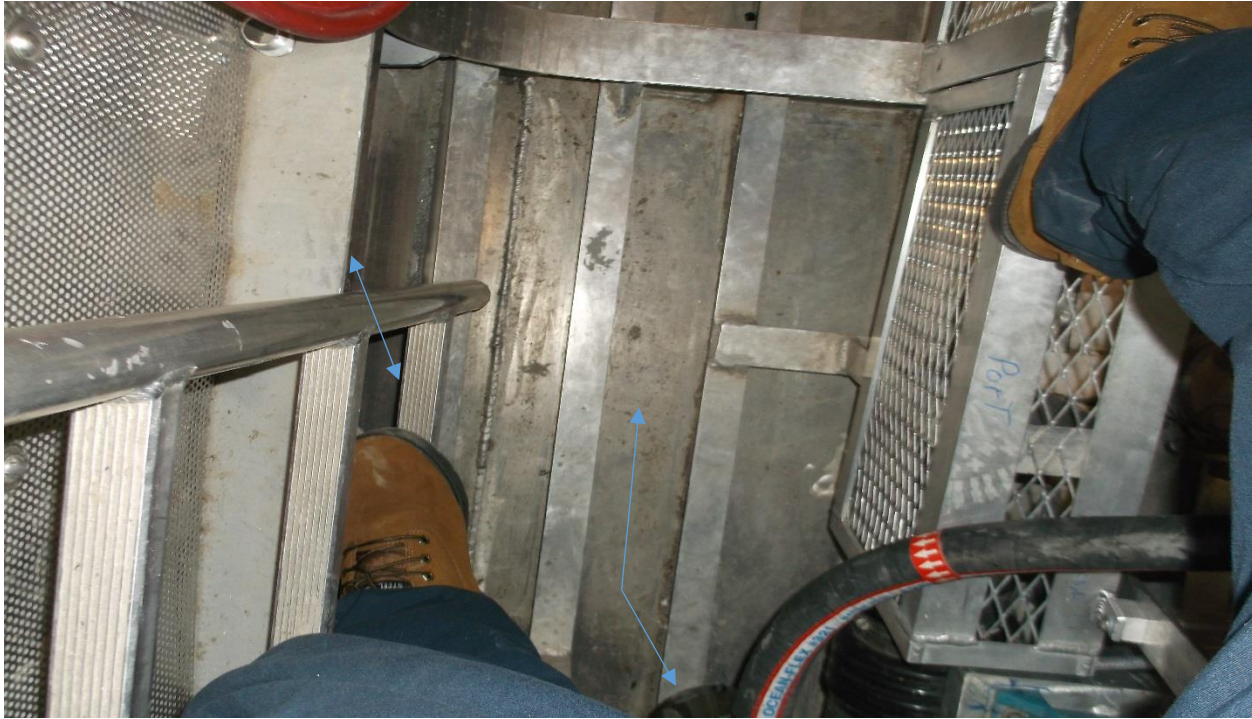
Typical view of aft machinery space ladder landings in need of floor plating (safety issue) also note bottom rung in-way side longitudinal member not allowing proper footing

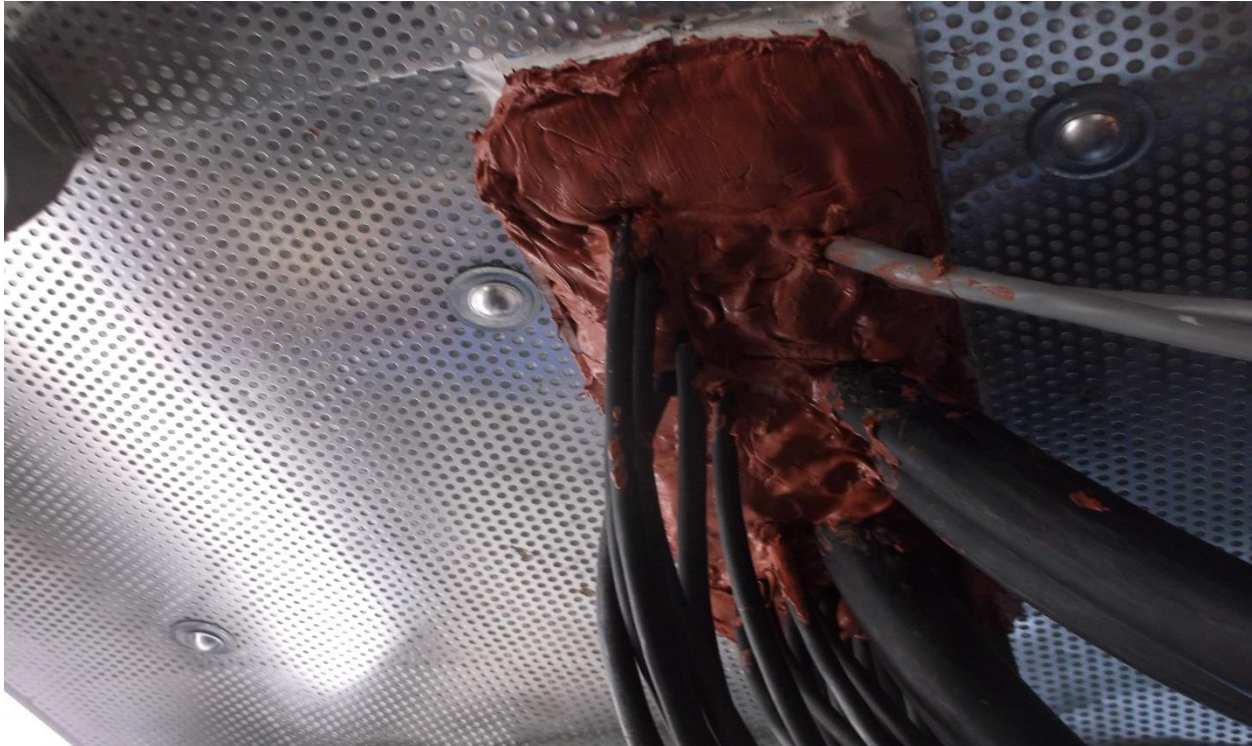
More sloppy cable passages with questionable fire block compound

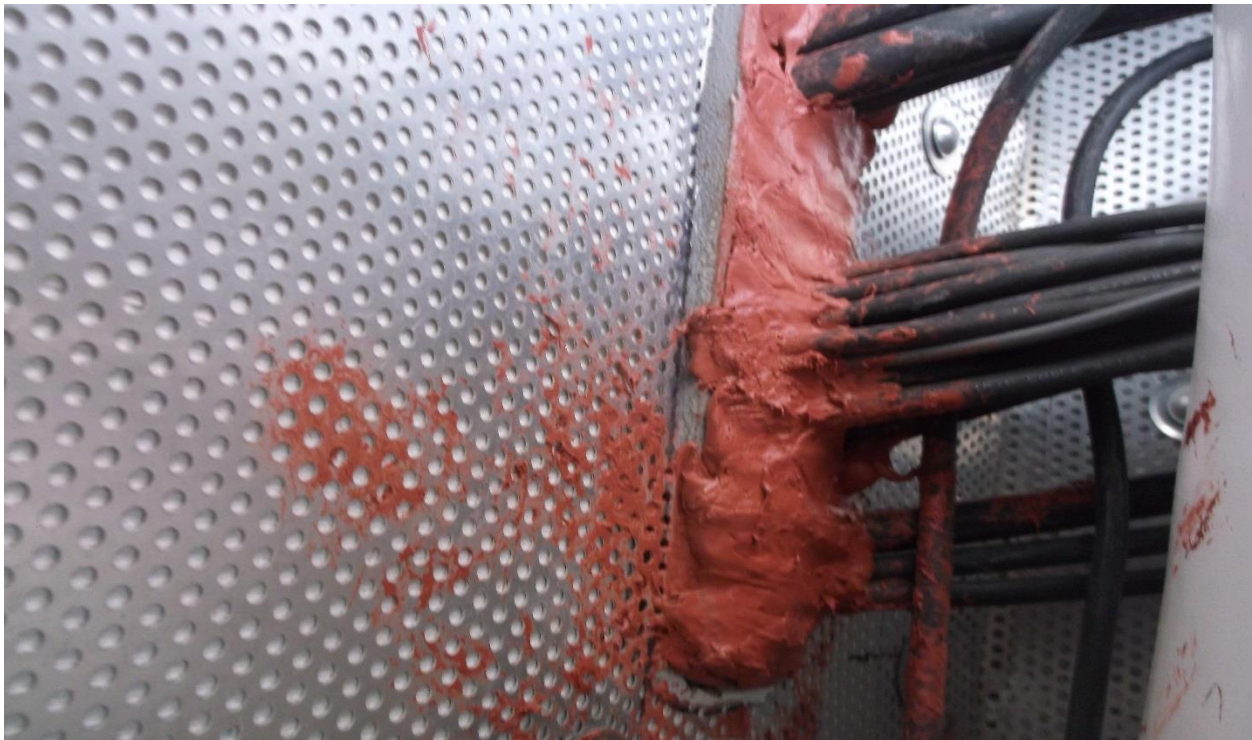
Cable passages behind exhaust system port aft machinery space

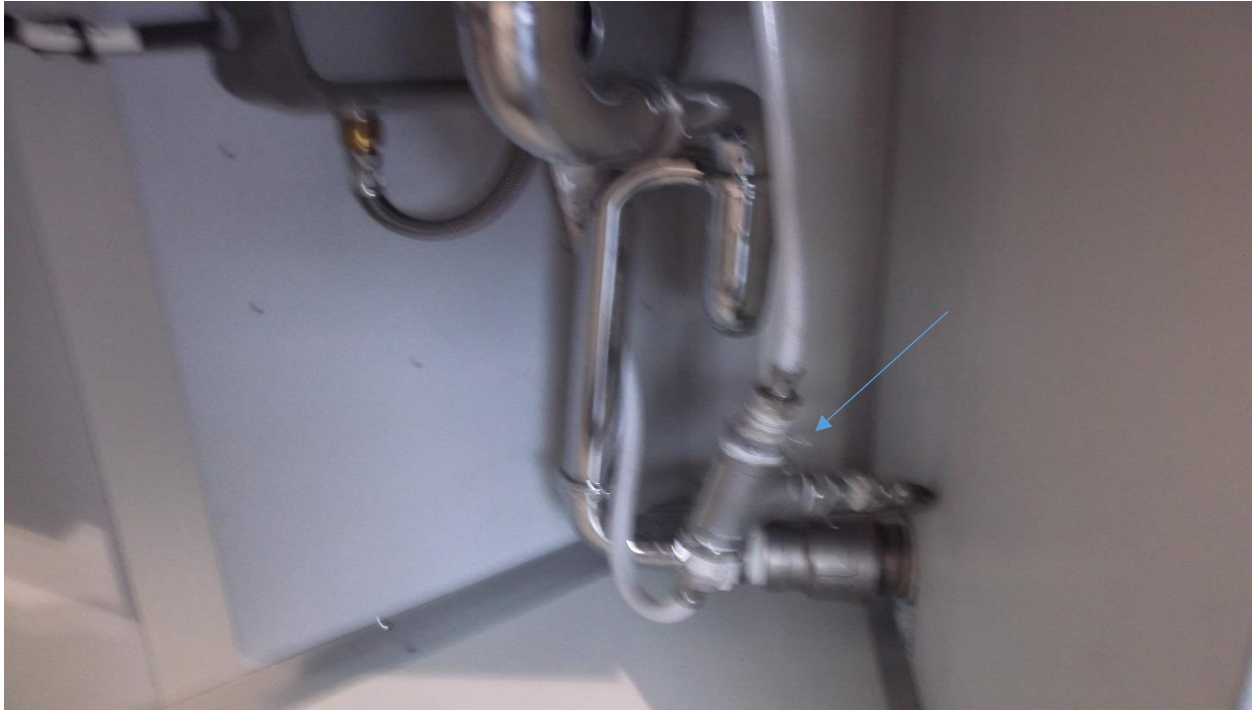
15. The port and starboard handrail cabling outboard port and starboard sides near double doors having some of the cables loose and/or broken loose.
16. The water supply hose and associated pipe connection under the sink in the crew office is not secured to cabinet and could possibly break off.

"RTA 1" under sink view of unsecured water piping and hose inside crew office

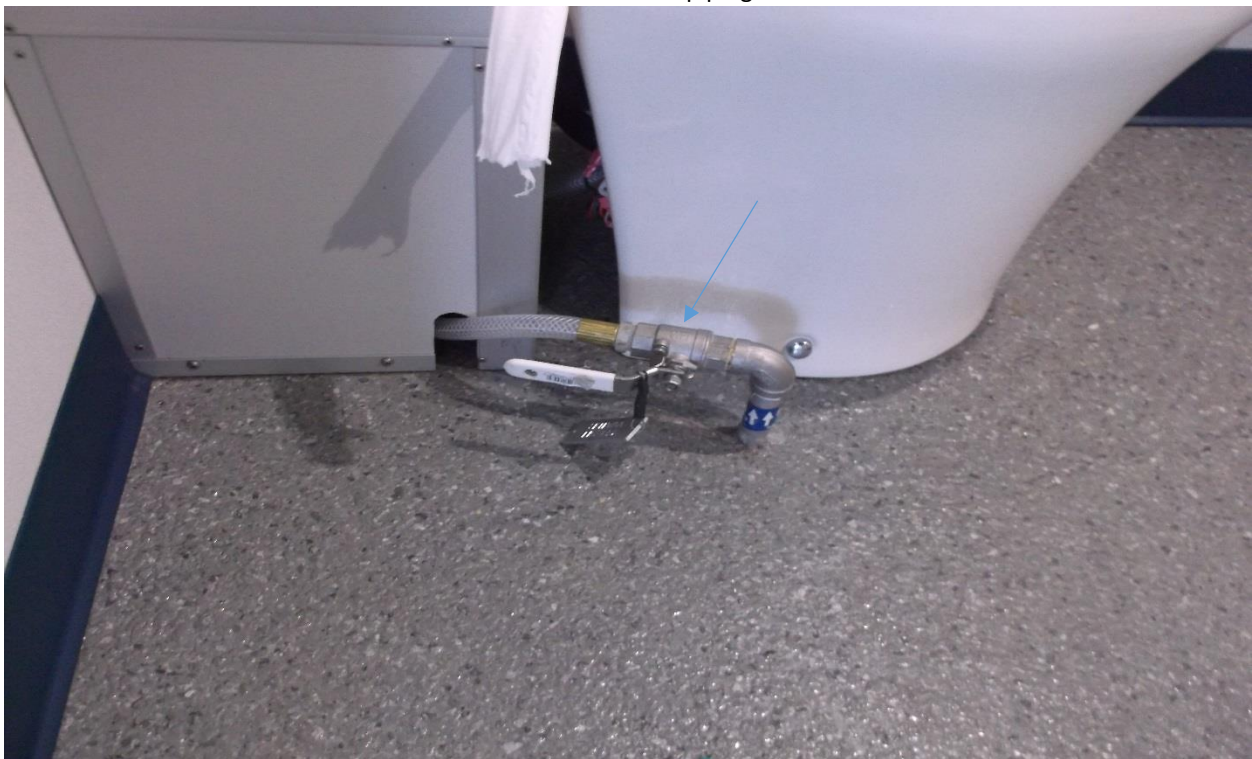
8. The ADA head toilet should have water in the bowl and requires adjustment. The water supply valve and piping to the toilet are exposed and could be damaged and/or broken if stepped on.

View of ADA head exposed water supply piping and control valve to toilet
